# Manhole Inspection Summary

Manhole # S03YY1007MH

Insp Date: **7/14/06 2:33 PM**

**Location** Address: **3407 TANEY RD**

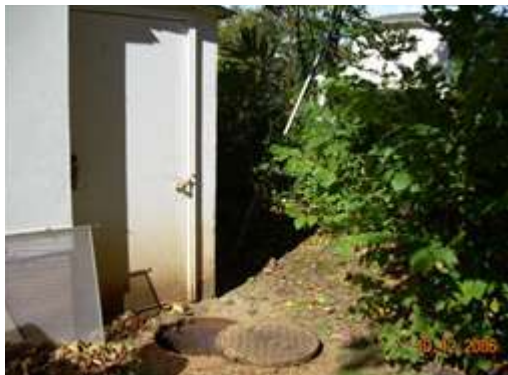
Location View

Comments **Manhole is in a backyard on private property. Unable to access.**  
**10.25.06 WM, JY inspected**

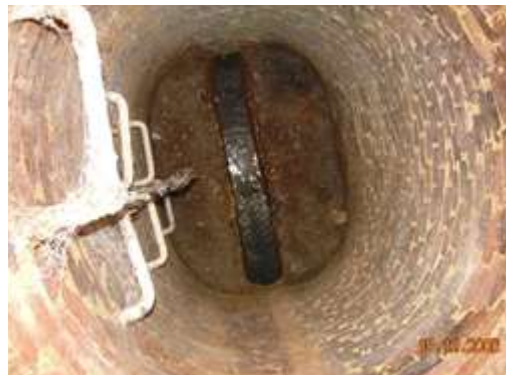
Top View

**Cover** Shape: **Circular** Diameter: **24** (in.) Length: (in.) Dist A/B Grade: **0** (in.)  
Type: **Sanitary** Condition: **Sound** Cover Material: **Cast Iron**  
Properties: ☐ Bolted ☐ Vented ☐ Water Tight ☐ Water Tight Insert

**Barrel** Material: **Brick** ☐ Parged  
Shape: **Circular** Diameter: **42** (in.) Length: (in.)  
Condition: ☒ Sound ☐ Cracked ☐ Root Intrusion ☐ Loose Brick ☐ Deteriorated  
Infiltration: ☒ None ☐ Joint ☐ Cracks ☐ Mortar ☐ Roots ☐ Wall

**Bench** ☒ Exists Material: **Brick** ☐ Parged ☒ **Debris** (not Condition related)  
Condition: ☒ Sound ☐ Cracked ☐ Root Intrusion ☐ Deteriorated ☐ Leaks ☐ Debris

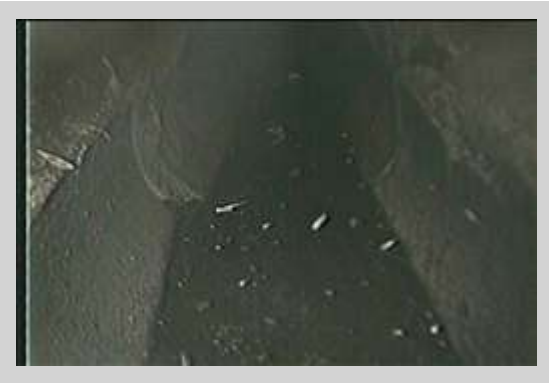
### 8 in. Circular Gravity Sewer Pipe Out @ 12 O'Clock

Pipe Material: **Clay** ☐ Pipe Lined

Invert Depth: **9.76** (ft.) Flow Characteristics: **Slow**

Deposits: ☒ None ☐ Mud ☐ Sludge ☐ Debris ☐ Grease

Infiltration: **None** Pipe Seal Cond: **Sound**

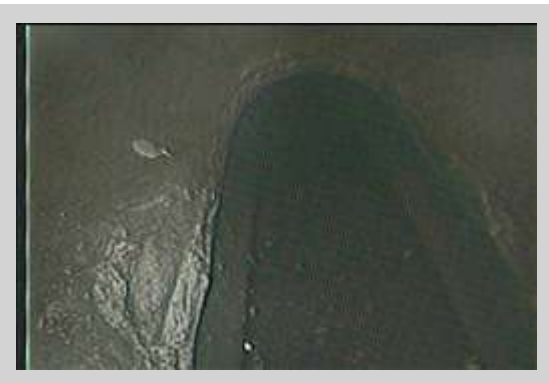
### 8 in. Circular Gravity Sewer Pipe In @ 6 O'Clock

Pipe Material: **Clay** ☐ Pipe Lined

Invert Depth: **9.69** (ft.) Flow Characteristics: **Slow**

Deposits: ☒ None ☐ Mud ☐ Sludge ☐ Debris ☐ Grease

Infiltration: **None** Pipe Seal Cond: **Sound**
